Debris/Ice/TPS Assessment and Integrated Photographic Analysis of Shuttle Mission STS-111

Author Name: Armando Oliu

June 2005

June 5, 2002

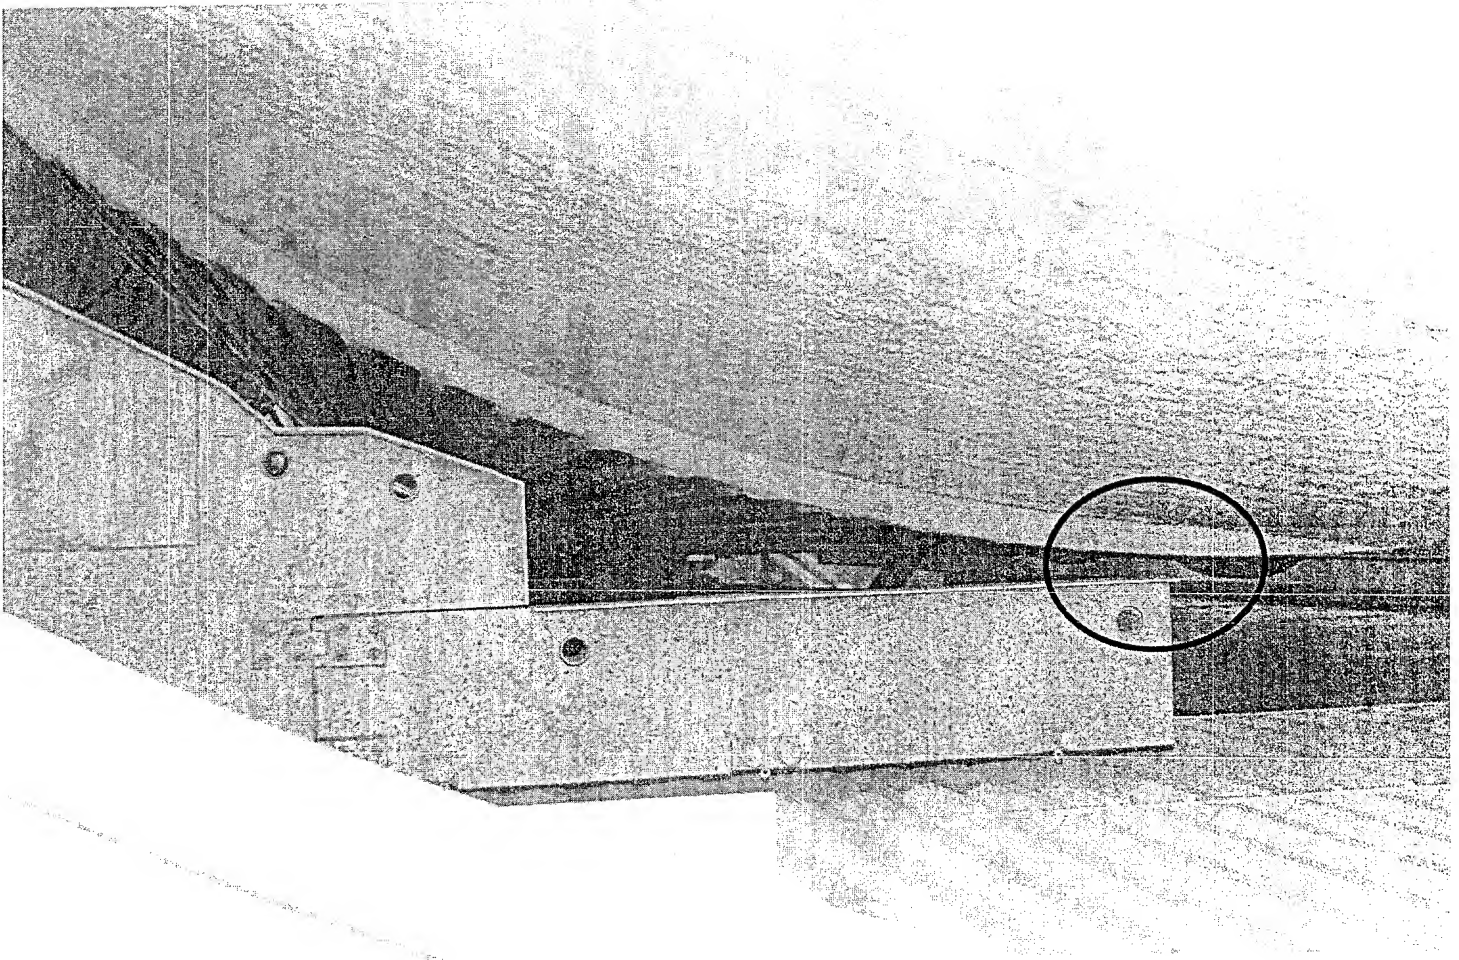
- -Y ET access platform flip is in down position. This flip needs to be raised prior to RSS retract. The end of the platform is within 3.5 inches of the External Tank.
- Excessive sand/debris on MLP deck and in gutter around MLP zero level.
- Two missing handrails (S2-16 and P4-1) and one broken pip pin (handrail S4-16) from removable handrails around the SRB exhaust hole. The handrails were already removed and were situated on the MLP deck. Pip pins need to be accounted for.

Photo 2: -Y ET access platform flip is in down position (out of configuration).
Clearance at closest point was less than 3.5 inches.

All items were in-work at the conclusion of walkdown. The configuration of the ET access platform was being corrected and the missing pip pins on handrails were located or accounted for.

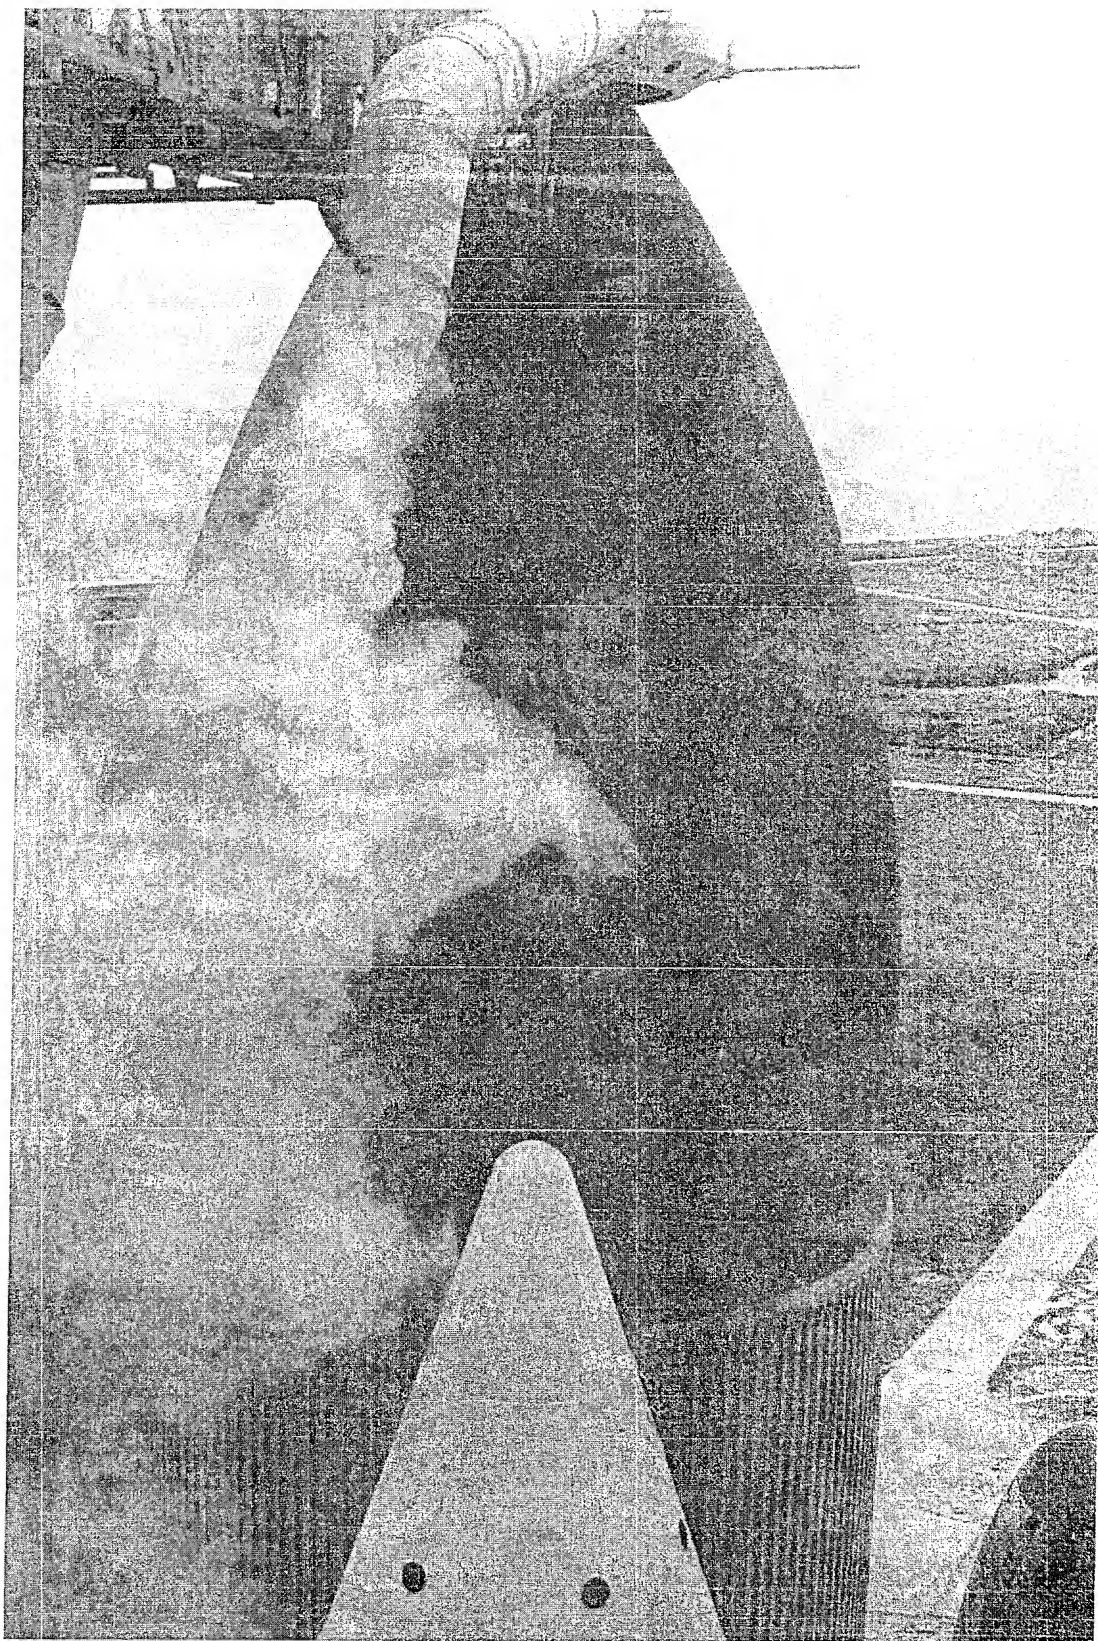
Photo 3: LO2 tank acreage.

Very little condensate was present on the LO2 tank acreage. Surface temperature ranged from 65 to 83 degrees Fahrenheit. There were no acreage TPS anomalies.

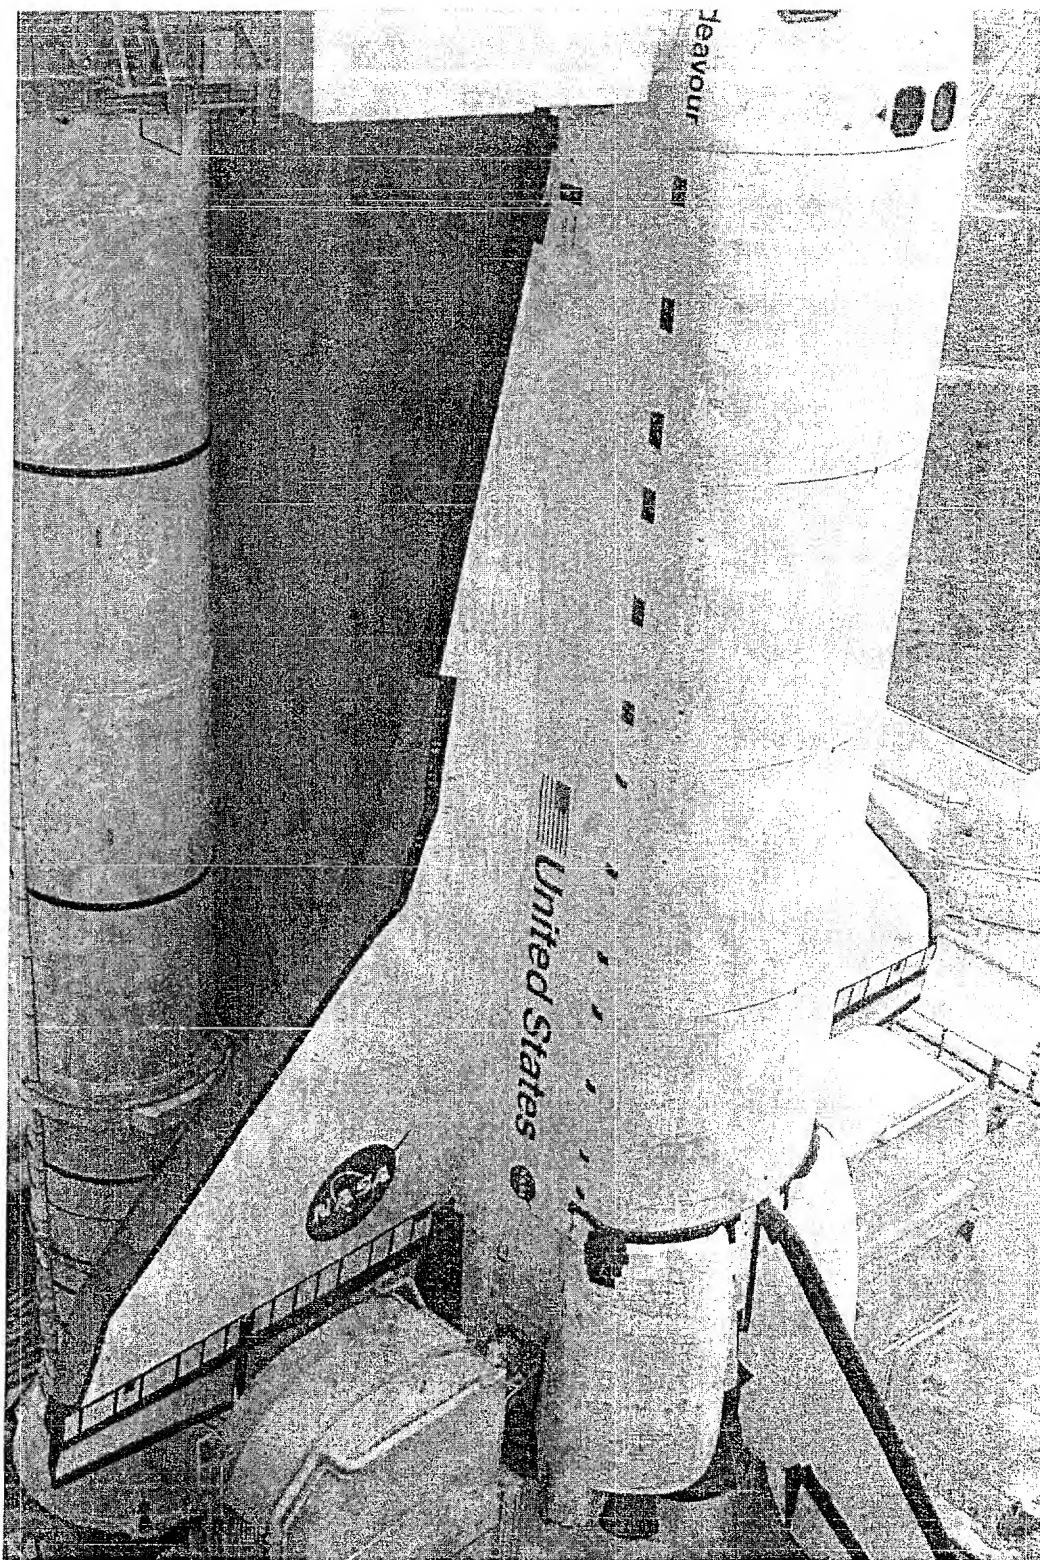
Photo 4: LH2 tank acreage.

The LH2 tank was wet with light condensate on the upper portion and moderate condensation at the aft end. Surface temperature ranged 64 to 83 degrees Fahrenheit. There were no acreage TPS anomalies.

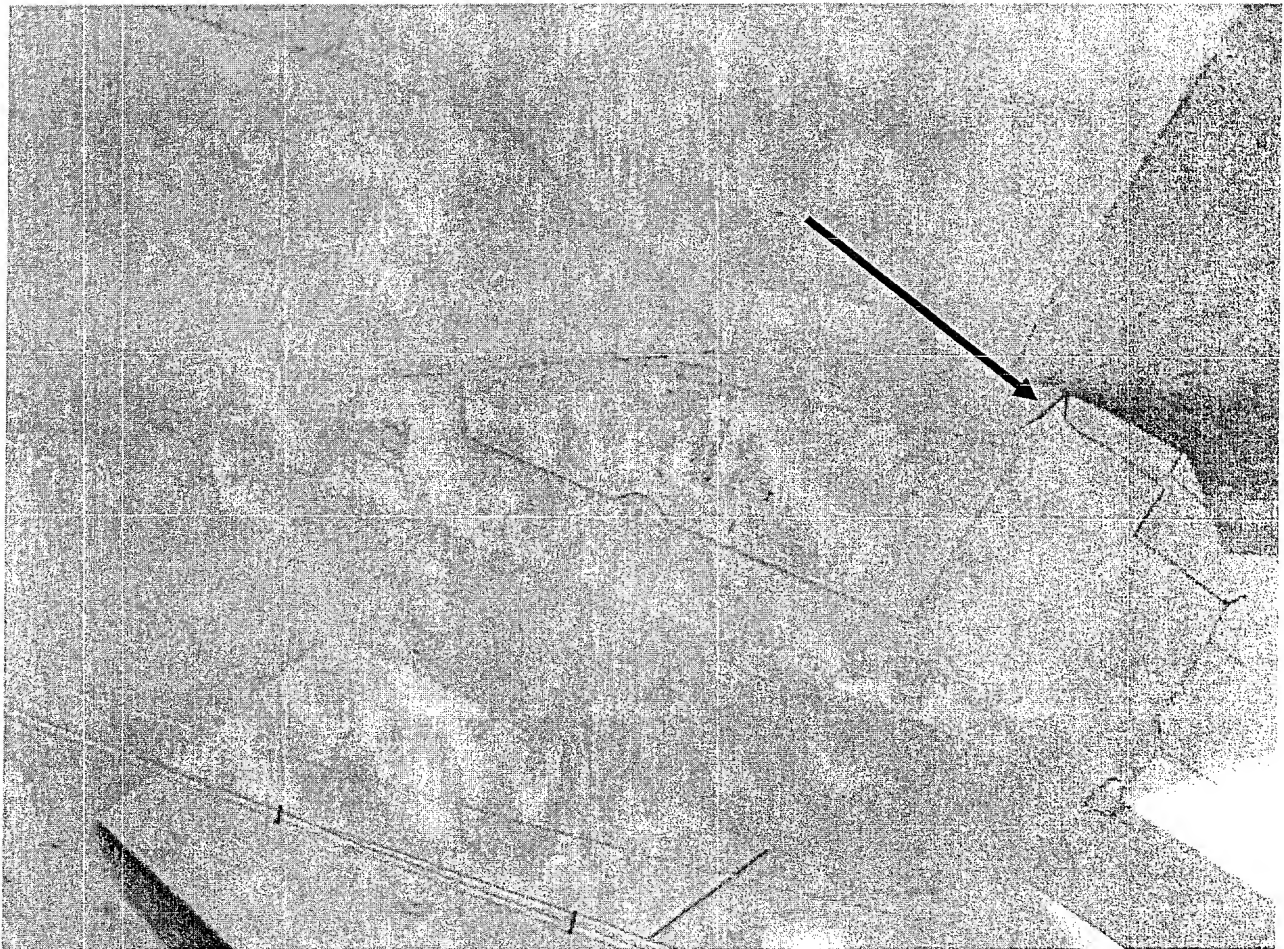
Photo 5: Crack in -Y Vertical Strut TPS

A 4 inch long and 1/4 inch wide stress relief crack was observed in the -Y vertical strut TPS with no offset. This condition has been observed on previous vehicles and found acceptable for flight per the NSTS-08303 criteria.

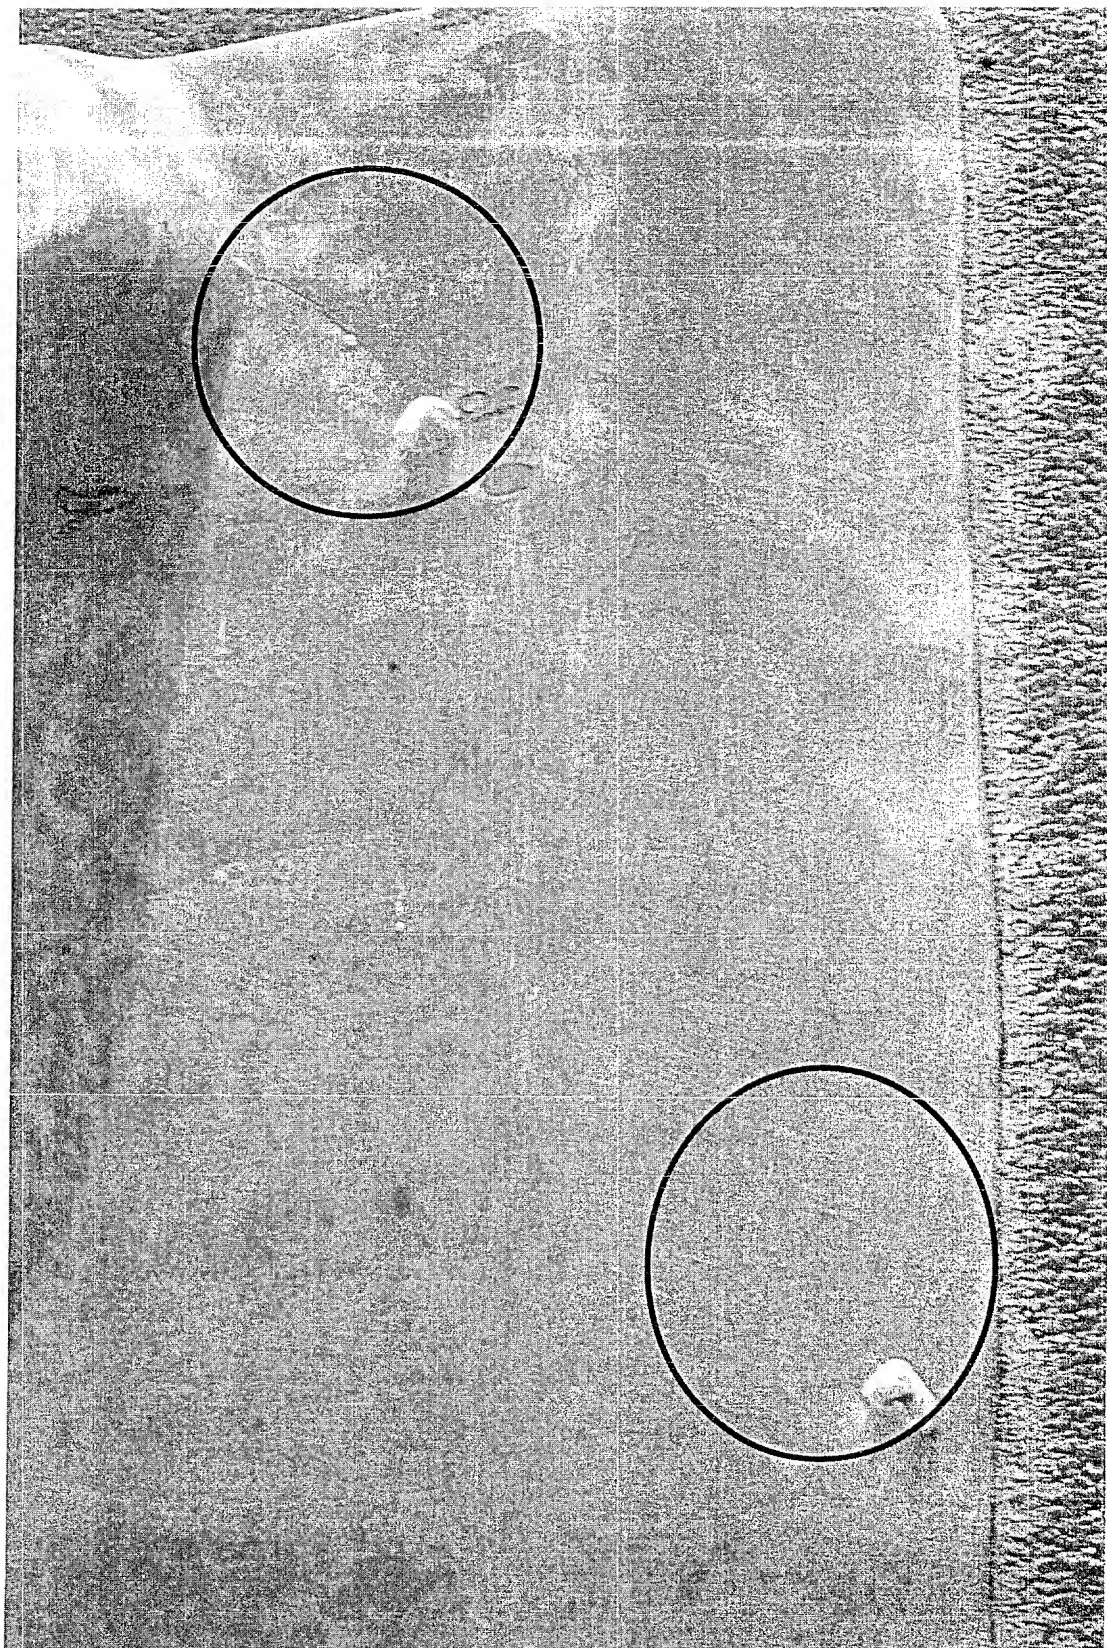
Photo 6: Cracks in +Y Longeron TPS closeout.

Two cracks were observed in the +Y longeron TPS closeout. The cracks also had 4 frost balls associated with them. IPR-111V-095 was generated since the condition is not covered in the NSTS-08303 Acceptance Criteria.

In the forward portion of the longeron closeout was a 12 inches long, with no measurable width (hairline), crack propagating diagonally aft. This crack had three frost spots associated with it. The second crack, located at the middle portion of the longeron closeout, was 12 inches long with no measurable width. This crack also propagated diagonally and had a frost ball at its aft end. Neither of the cracks followed knit lines or exhibited offset.

The cracks most likely resulted from a combination of typical thermal/mechanical induced TPS stresses and localized defects in the thick BX-250 closeout foam. An assessment was performed that consisted of two parts addressing the ET thermal/structural integrity for flight and possible debris threat to Orbiter lower surface tiles. With all the data taken, there was no evidence of debonds and the condition appeared to consist of shallow surface cracks only.

Two cracks were observed in the +Y longeron TPS closeout. The cracks also had 4 frost balls associated with them.

In conclusion, the condition was accepted for flight by MR.

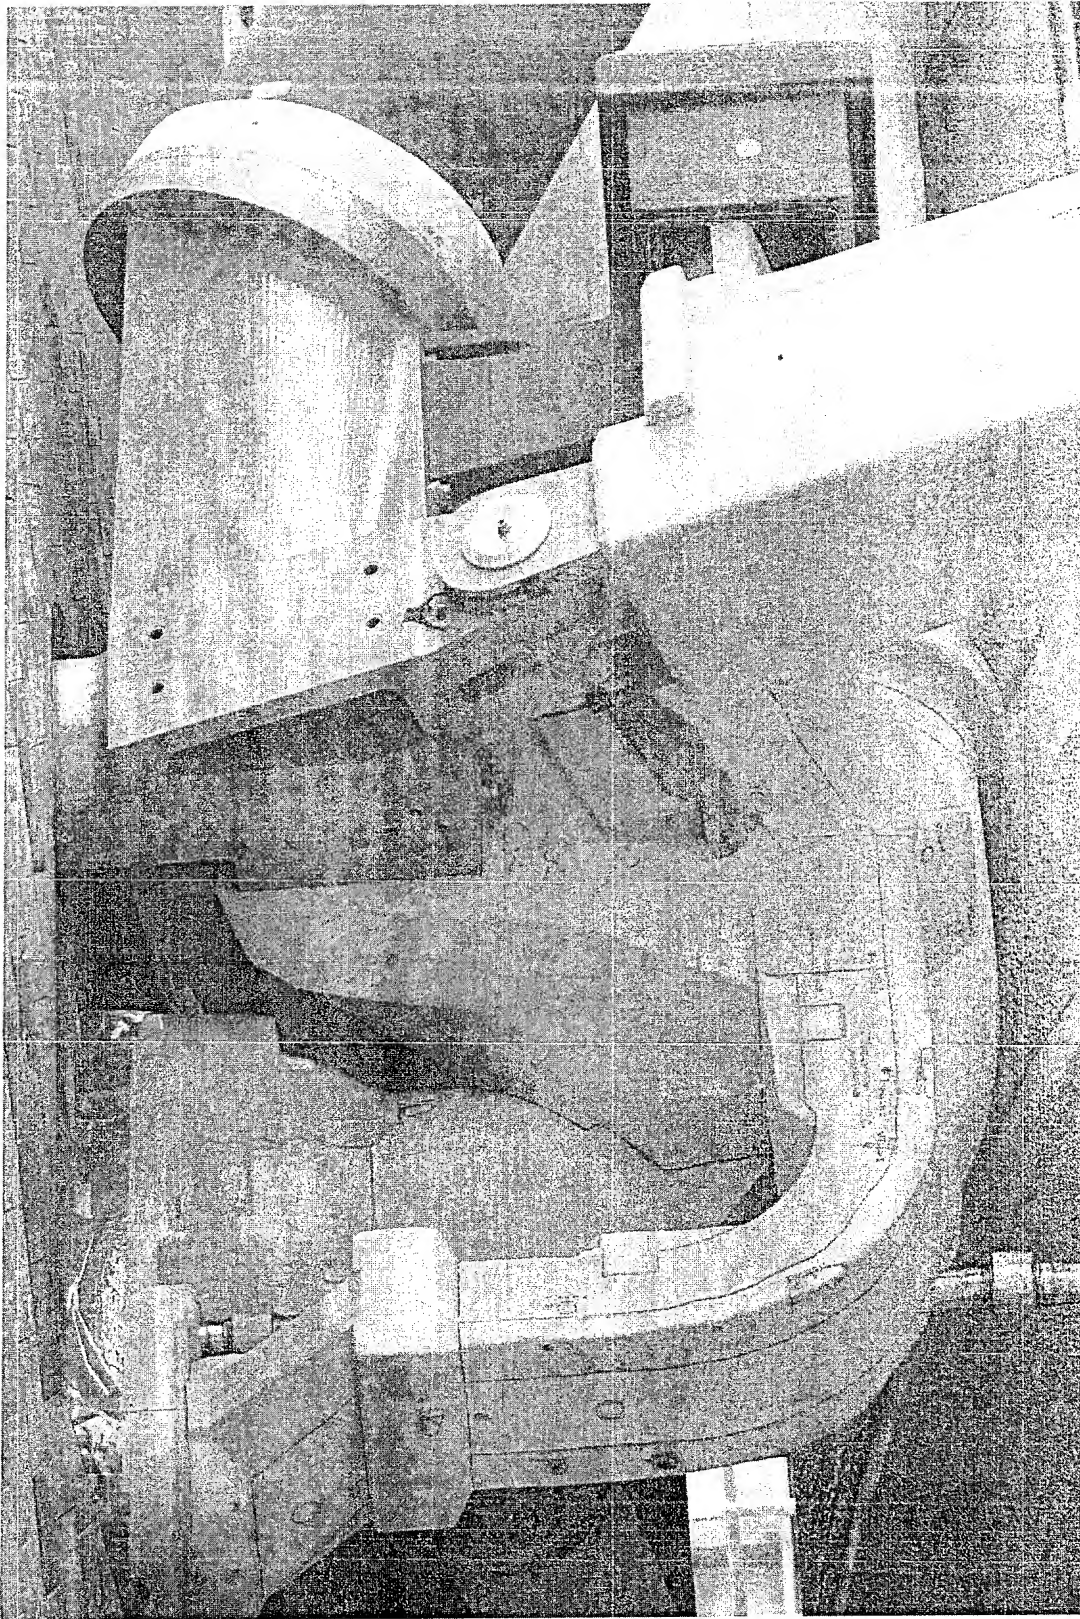
Photo 7: LO2 Umbilical area.
Ice/frost finger on pyro canister vent.

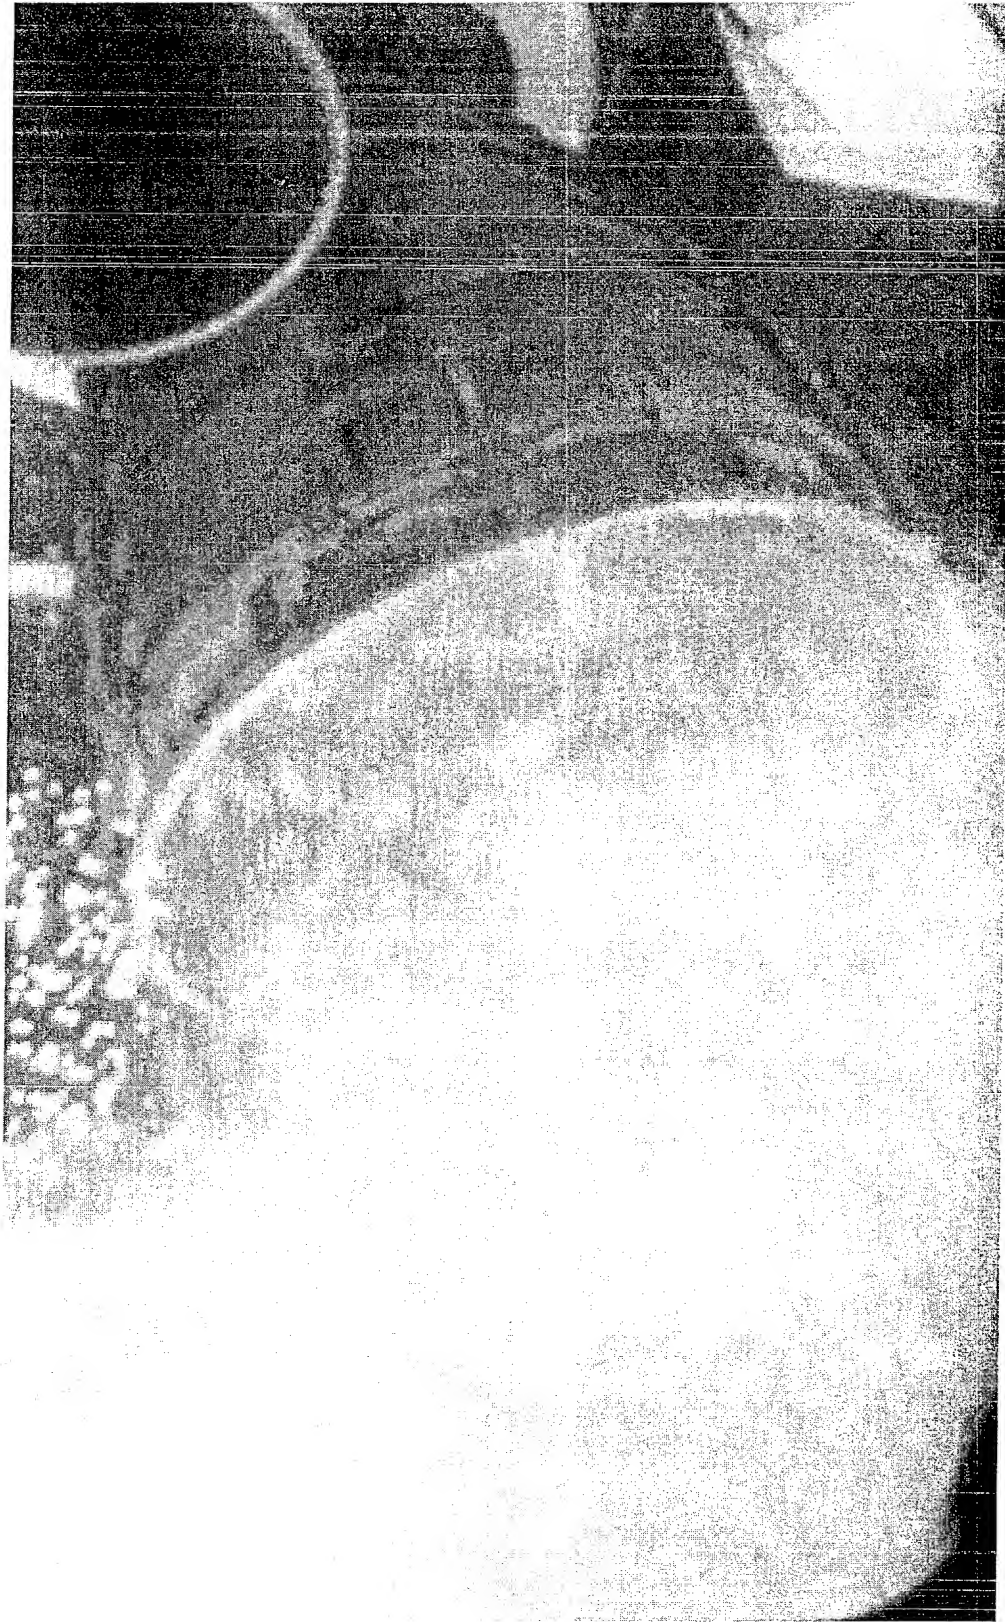
Free-burning GH2 blown under body flap by wind during SSME ignition.

Photo 8: SSME Flare approximately 1.5 seconds into startup sequence.

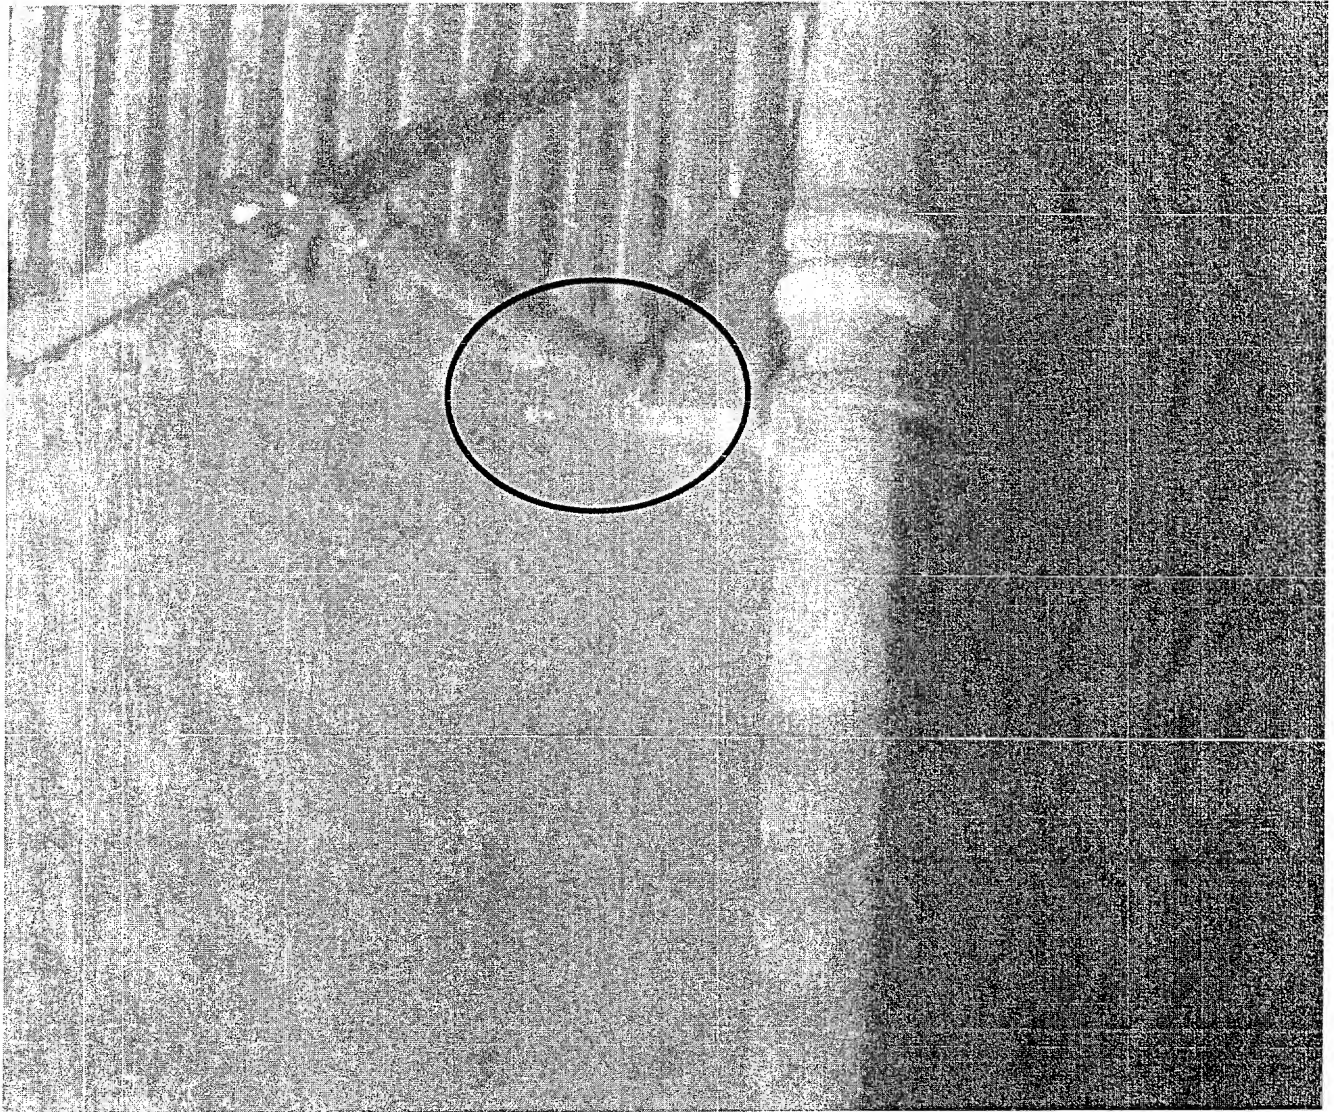
Photo 9: External Tank post-separation.

Three TPS divots, approximately 1.5 inches in diameter, were observed on the intertank-to-LH2 tank flange closeout near the +Y jack-pad closeout. One TPS divot, approximately 1.5 inches in diameter, was observed at the +Y bipod ramp-to-LH2 tank interface. The divots appeared shallow with no substrate exposed.

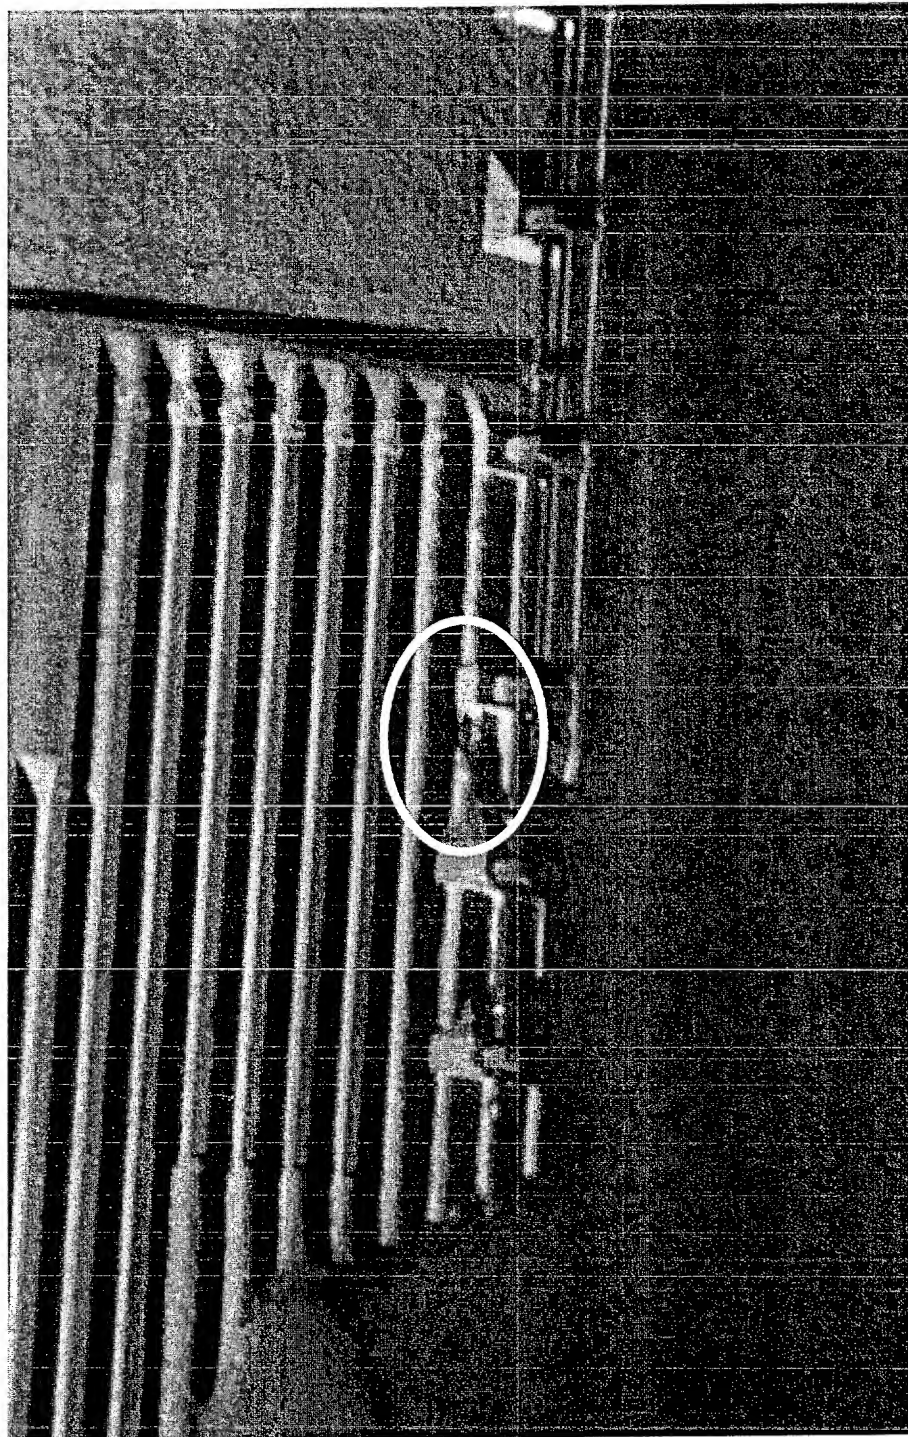
Photo 10: External Tank post-separation.

TPS divot (approximately 6 inches long by 2 inches wide) with exposed substrate located on an inter-tank stringer near the GO2 Press/Line ramp at station Xt -897.

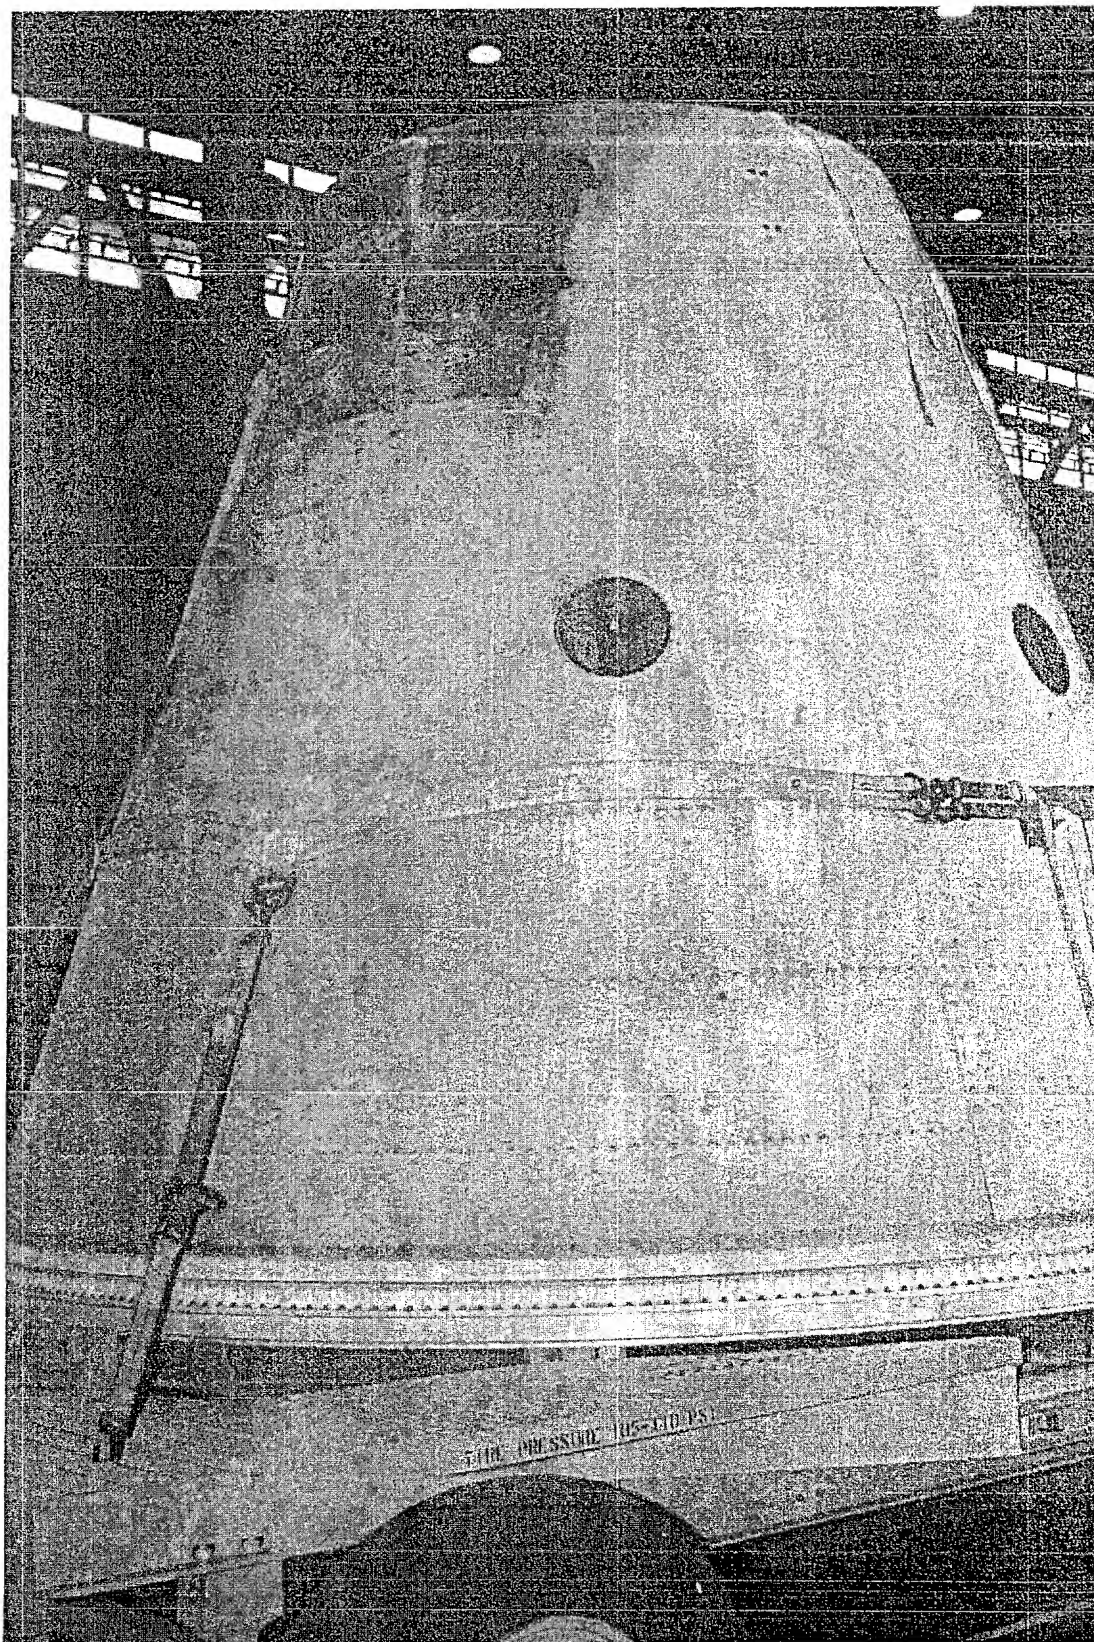
Photo 11: LH Frustum Post Flight Condition

The LH SRB frustum exhibited no debonds/unbonds or missing TPS.

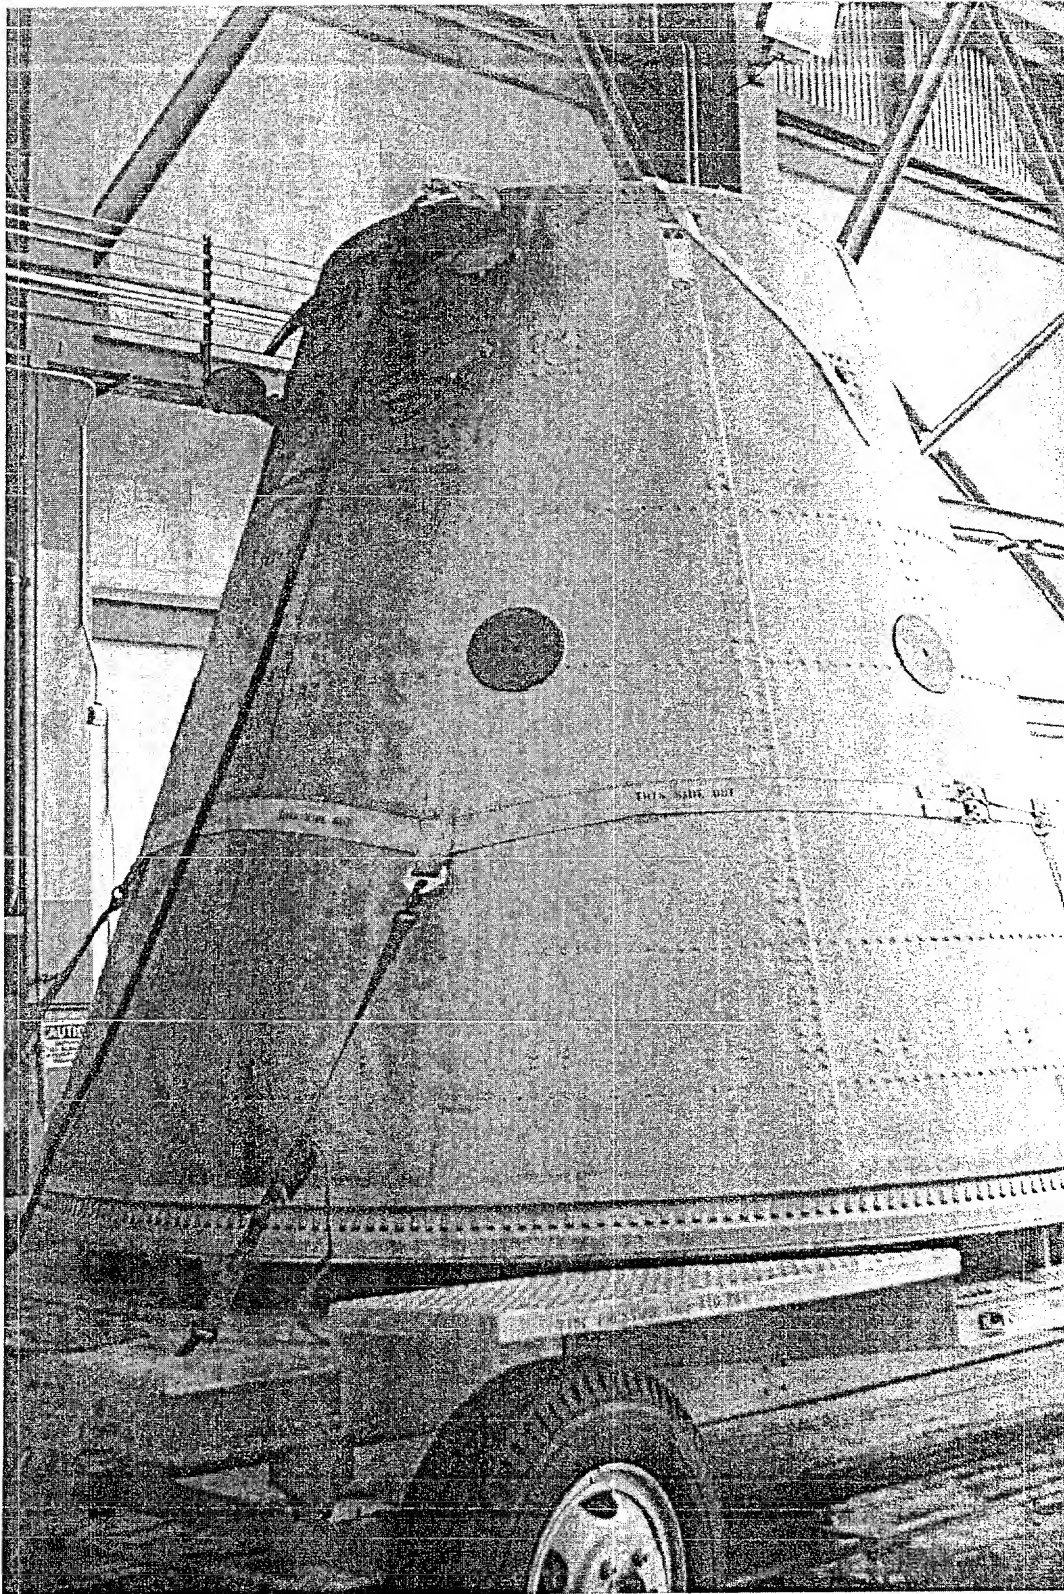
Photo 12: RH Frustum Post Flight Condition

The RH SRB frustum exhibited no debonds/unbonds or missing TPS. Note the cover attach ring bent at the hinge by parachute riser entanglement.

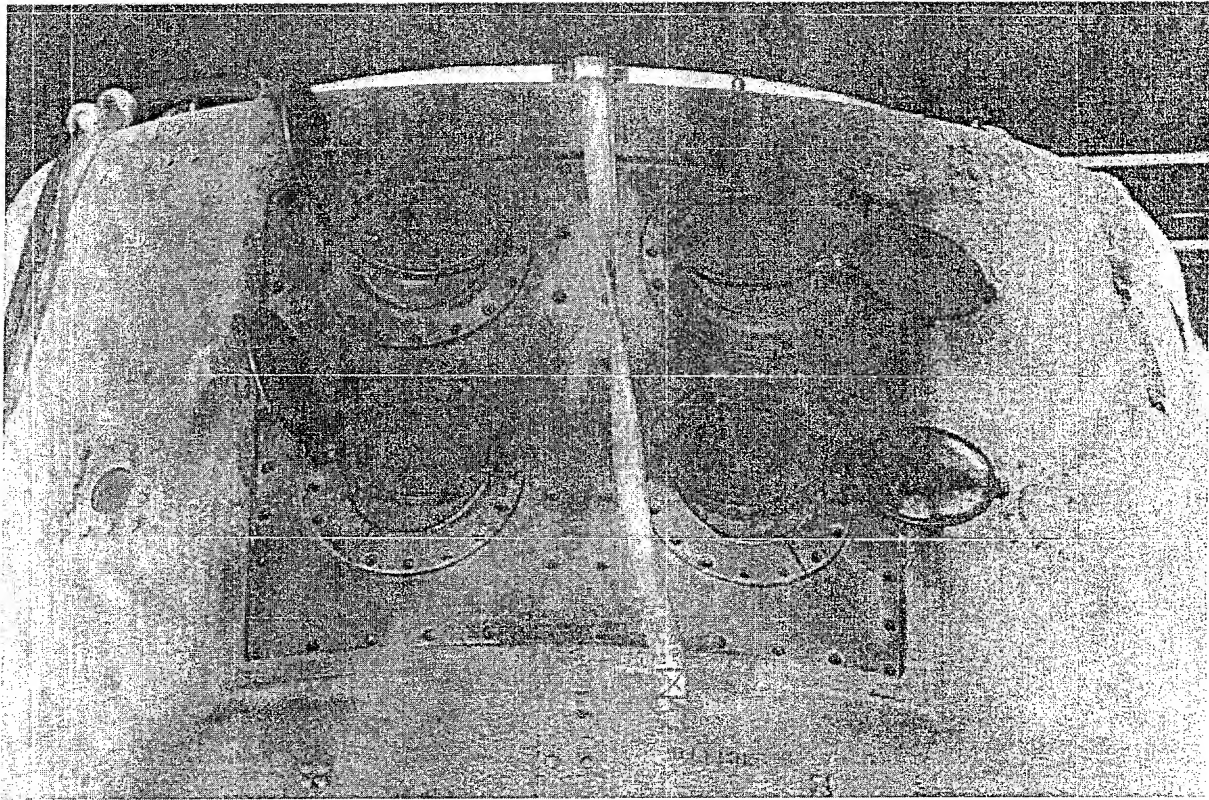
Photo 13: BSM Cover Condition

Two LH cover attach rings had been bent at the hinge by parachute riser entanglement.

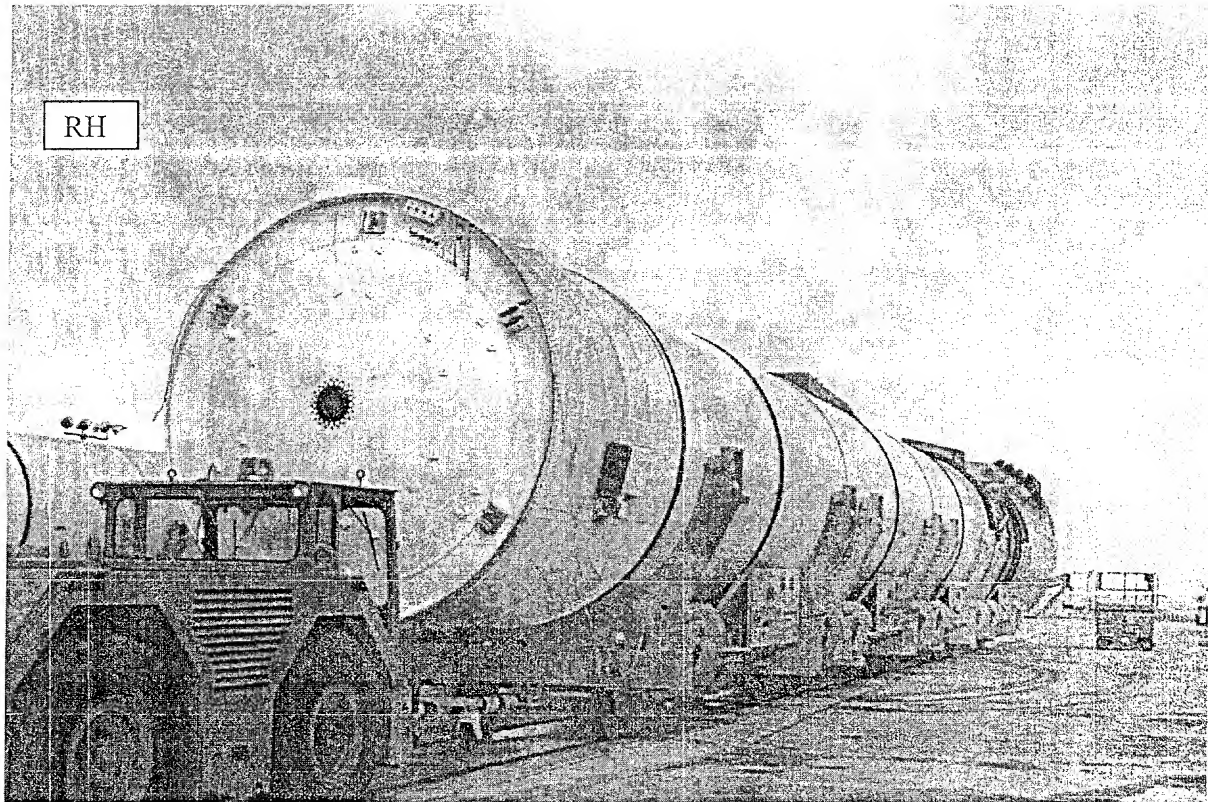
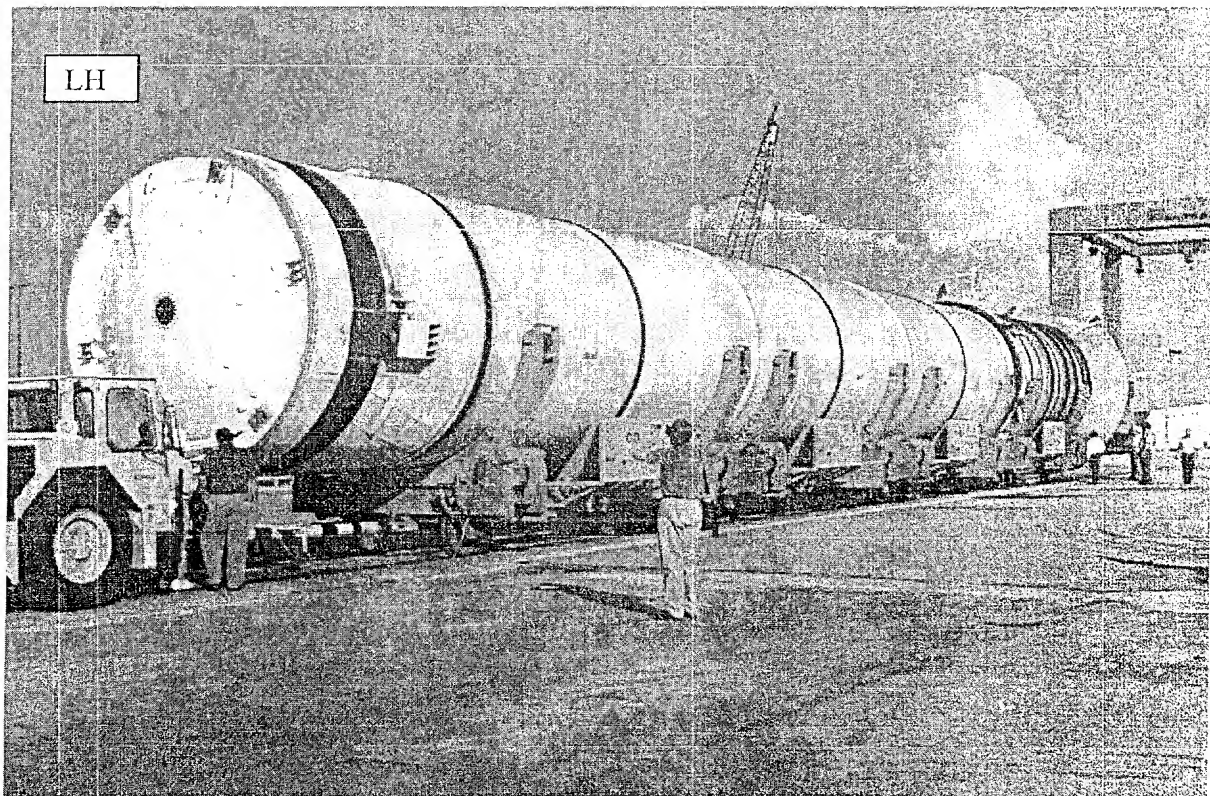
Photo 14: SRB Post Flight Condition

Both SRB's were found in good condition regarding debris assessment

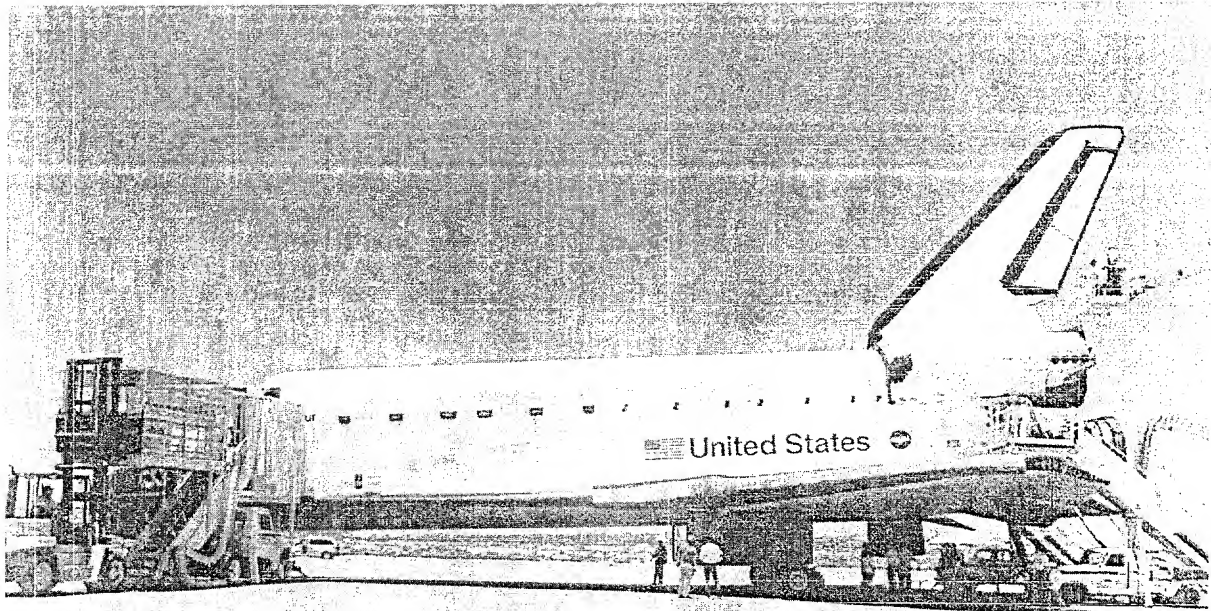
Photo 15: Overall View of Orbiter sides

The Orbiter lower surface sustained 47 total hits, of which 21 had a major dimension of one inch or larger. Both of these numbers are within family.

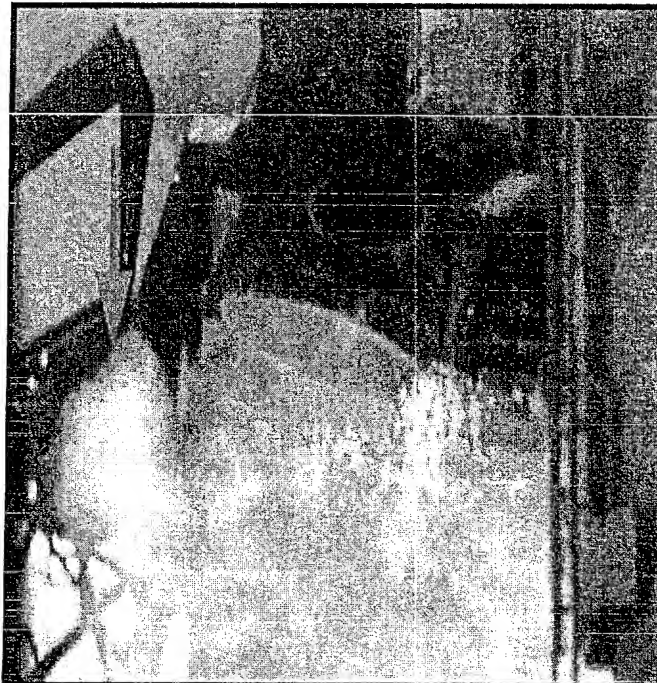
Figure 2.1 (A) Orange Flash Seen in SSME #1 During Ignition (Camera E2)

A large, late-occurring, orange-colored flash (probably free burning hydrogen) was seen in the +Z /-Y direction from the SSME #1 rim during SSME ignition (21:22:45.541 UTC). On the close-up camera E20 view, the flash appeared to originate within or just below the rim of SSME #1 (21:22:45.537 UTC). A second smaller flash was visible aft of the larger flash (Cameras E2, E19, E20, E52, E63, E76). The previous mission STS-110 launch video was reviewed and a similar but much smaller flash near SSME #1 was also present during the STS-110 SSME ignition. (The STS-110 flash occurred 1.5 seconds prior to the SSME #1 Mach diamond formation compared to STS-111 where the flash occurred 1.2 seconds prior to the SSME #1 Mach diamond formation.). No out-of-family flashes were seen on the STS-108 and STS-109 videos.
